# ***INSPECTION REPORT***

## ***AMSTON LAKE DAM CT DEEP #06704***

AMES ROAD  
TRIBUTARY TO RAYMOND BROOK  
AMSTON / HEBRON, CONNECTICUT

## DAM SAFETY PROGRAM DAM INSPECTION REPORT FORM – FOR REGULATORY INSPECTION

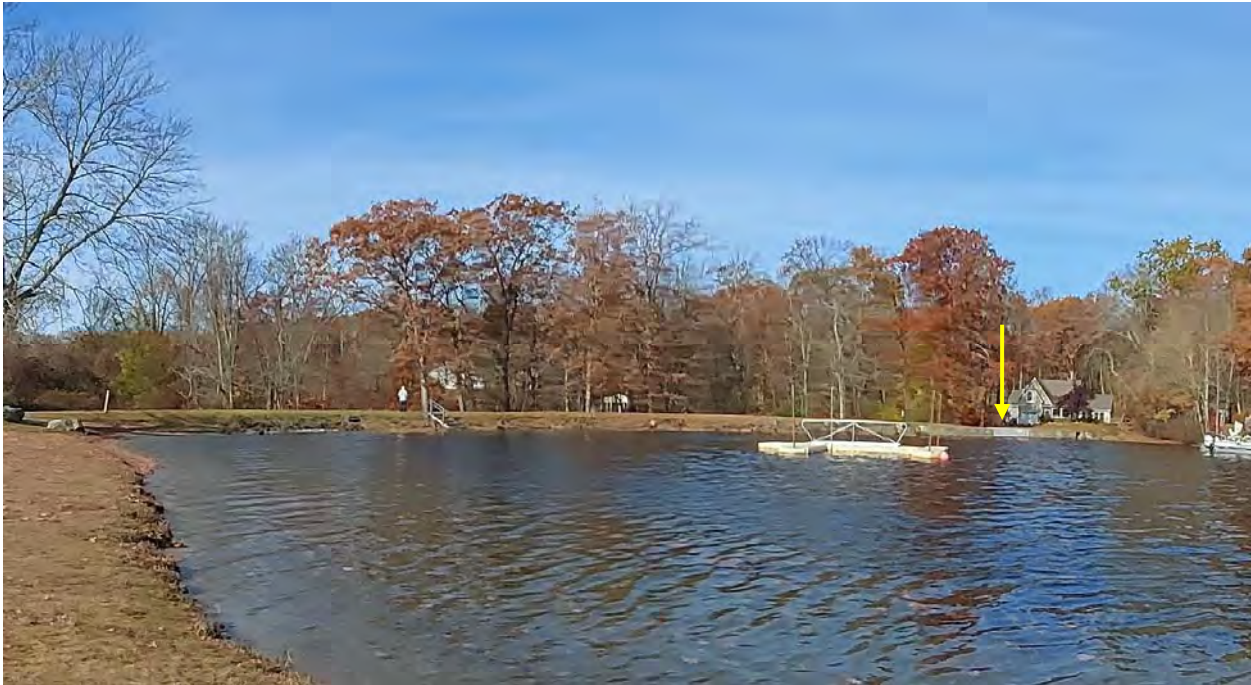
Photo 1 – An overview of Amston Lake Dam as seen from the left upstream shoreline. For reference, the arrow points to the location of the spillway.

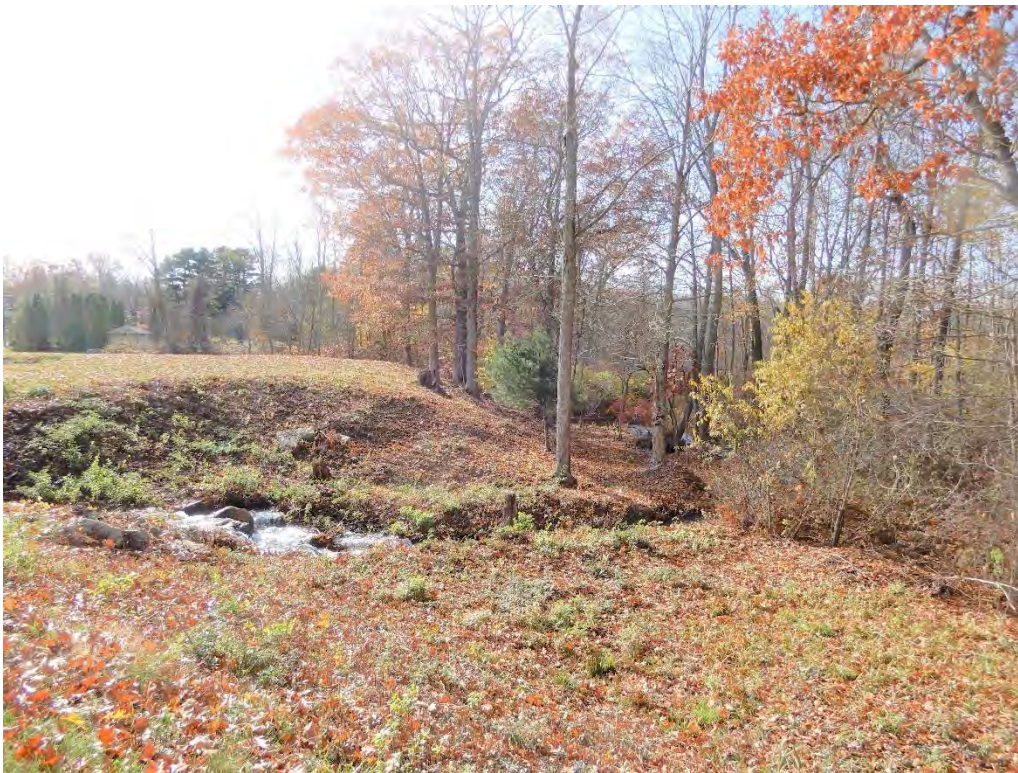
Photo 2 – An overview of the dam as seen from the right downstream embankment.

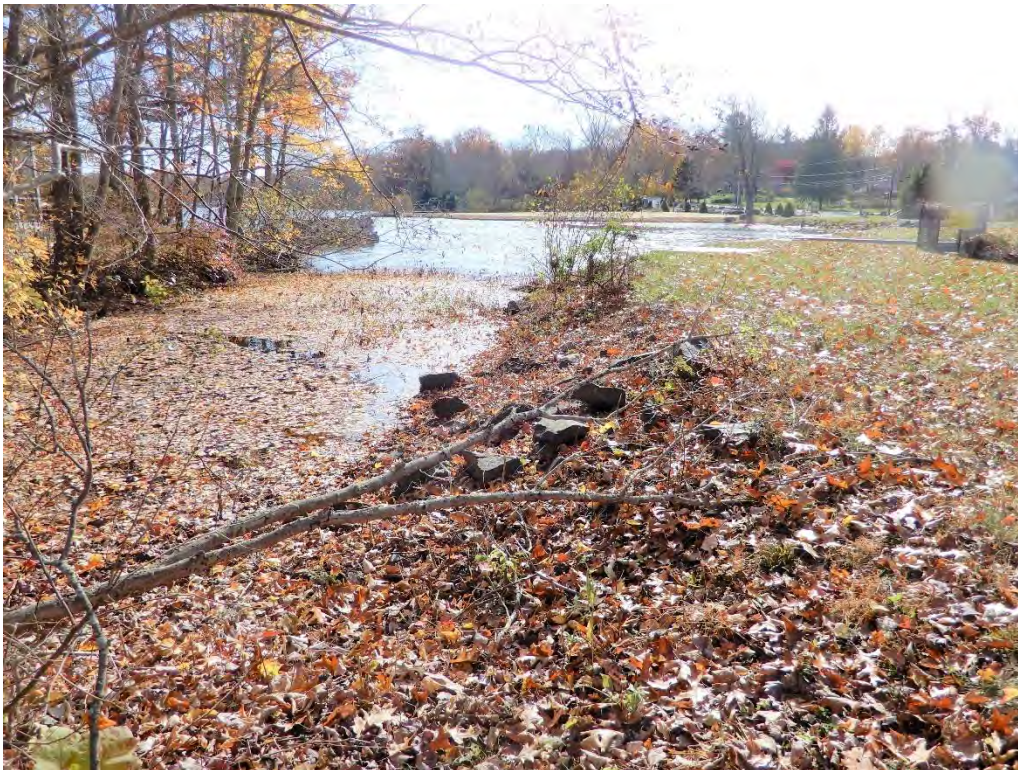
Photo 3b – The right upstream embankment. Although there is some leaf litter present from trees on the opposite shoreline, the embankment here is stable and well maintained.

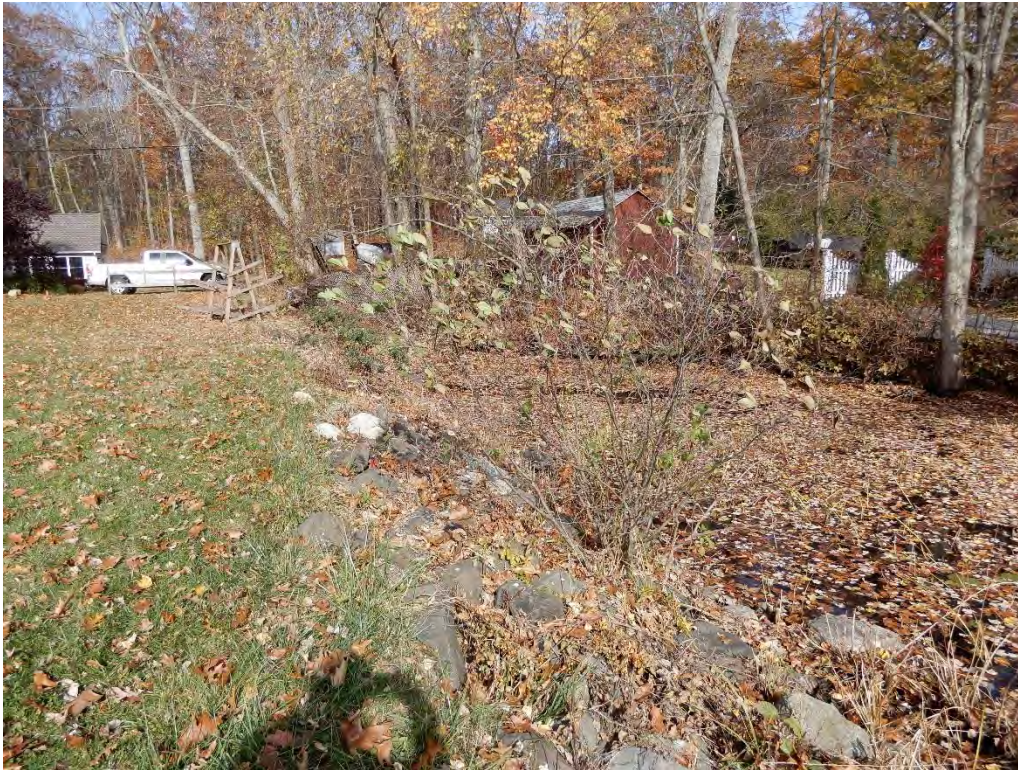
**Vegetative Cover:** The embankment has a grass cover, well maintained and in satisfactory condition. There were two small bushes along the right upstream slope which should be removed. Also recommended for removal are several trees on the left downstream slope and the left downstream toe, within the 25' clearing limit.

Photo 3c – A few of the right upstream embankment as seen from the right side of the spillway. Brush, such as that shown in the foreground, should be removed from the embankment

1. **Removal of Vegetation** – The overall dam is generally well maintained. As noted in the preceding observations, however, and shown in the following photographs, there are some areas of brush and several trees which need to be removed. The trees noted are situated along the downstream slope and toe area on the left side of the spillway. In general, DEEP guidelines and regulations require removal of trees within a 25-foot limit area of the dam's layout. Once trees, in particular, are cleared, a judgment should be made with the assistance of an engineer as to the efficacy of removing stumps and or root systems which may interfere with the safety of the dam.

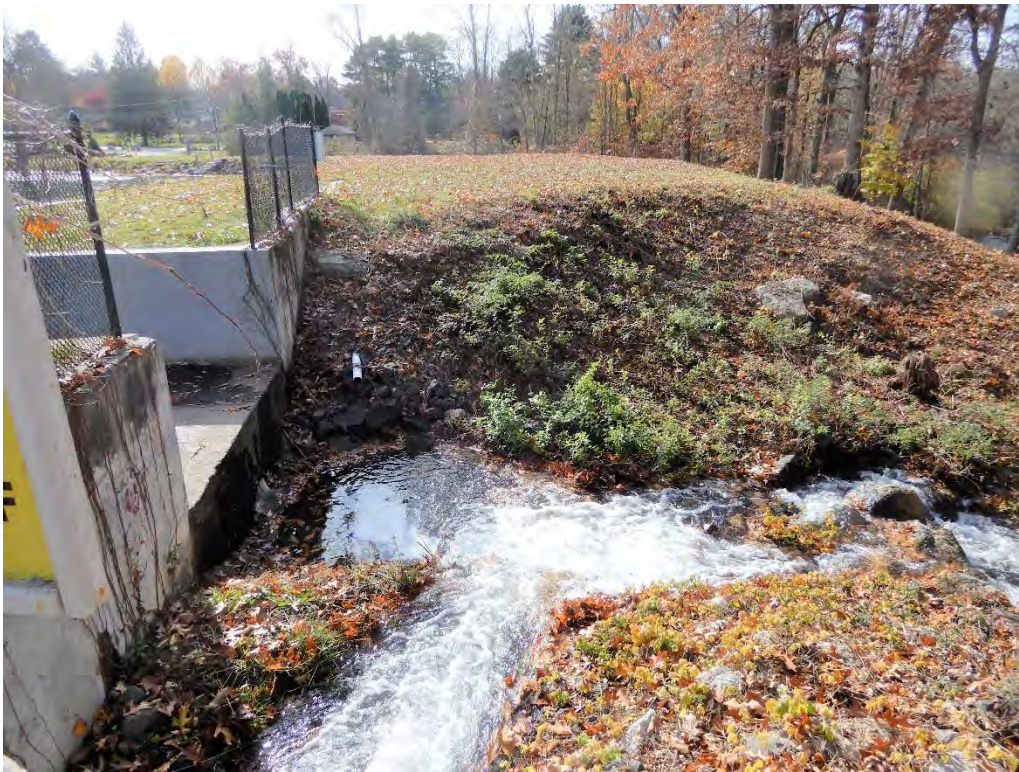
**Riprap:** Some small riprap is present at the downstream base of the spillway apron, in the plunge pool area. It is stable and in good condition, barring some minor brush growth between some of the stones.

Photo 14 – The stilling basin at the downstream end of the spillway discharge chute. The area is composed of small riprap stones and natural channel base materials, and is generally stable.

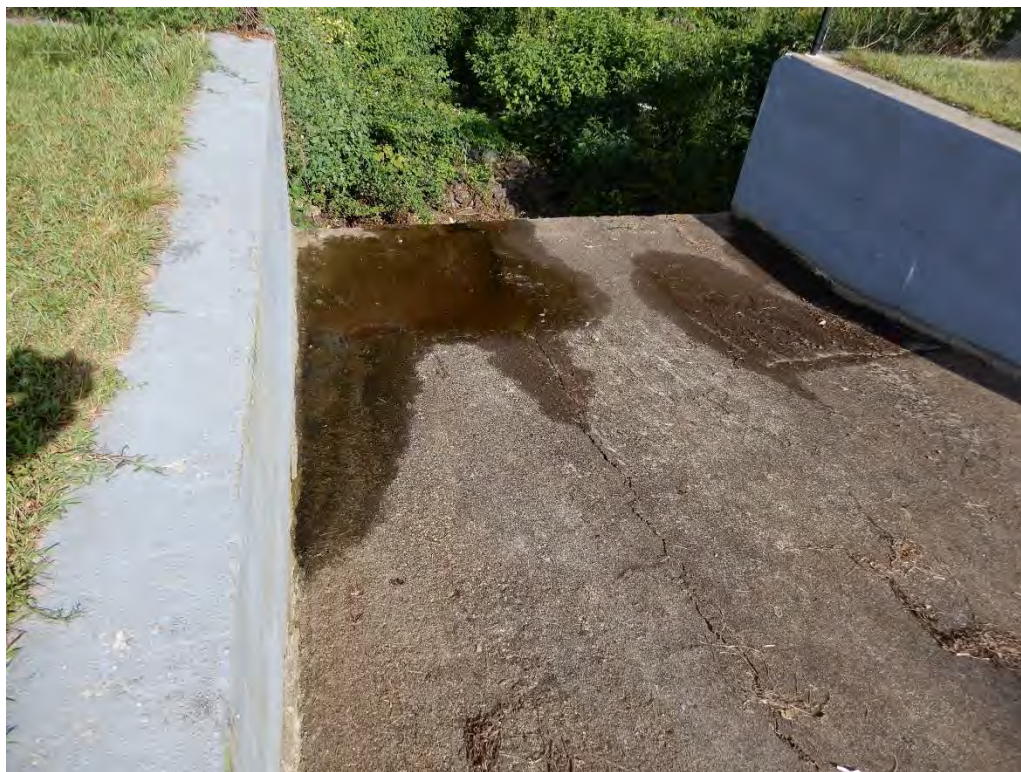
**Seepage / Foundation Drainage:** Minor seepage has been noted along the base of the two training walls near the end of the downstream apron. See photos for specific locations and additional information below under "Other".

**Other:** Seepage issues have been noted at the spillway location for at least the last 20 years. Cutoff walls on the upstream side have been installed to address this problem and it is, therefore, not considered a serious issue. Also, in the process of removing the older low level outlet, which had been located within the base center of the current spillway with an outlet at the bottom of the short vertical section at the downstream base, it was found that the interior of the spillway apron had several voids and was filled with stone rubble mixed with soil, extending toward the footing of the two training walls. The voids were subsequently filled with concrete to stabilize the base areas adjacent to the old pipe run wherever voids were noted. This, along with the seepage pointed out through the foliated bedrock, previously noted under the diving inspection section of Part II, General Dam Information, indicated that the seepage needs to be monitored on a long term basis and addressed as changes may occur.

Photo 21a – An overview of the spillway discharge apron, showing seepage near its left and right side base, apparently emanating from the bottom interface with the training walls. Also note thin cracks along the line of flow toward the center of the apron.

2. **Spillway Seepage** – As previously noted under Part II, General Dam Information / Diving Inspections, several dives have been completed at this site over the past 20 years. In addition, as noted under Part V, Primary Spillway, upstream cutoff walls have been installed, connected either to exposed bedrock or older underlying footings or walls and, during the abandonment of an older low level outlet within the spillway apron, several void areas were filled in. These have had some success in slowing down or eliminating major seepage points, but several minor ones continue to persist, potentially caused by inflow to and through foliated sections of bedrock on the upstream side of the dam. As such, we recommend a monitoring program to observe seepage areas for quantity and quality (i.e., turbidity) of outflow. Should there be a substantial increase in the quantity of flow or should there be a cloudy appearance suggesting transport of sediment, then an Engineer or the Dam Safety Section of the DEEP should be consulted.

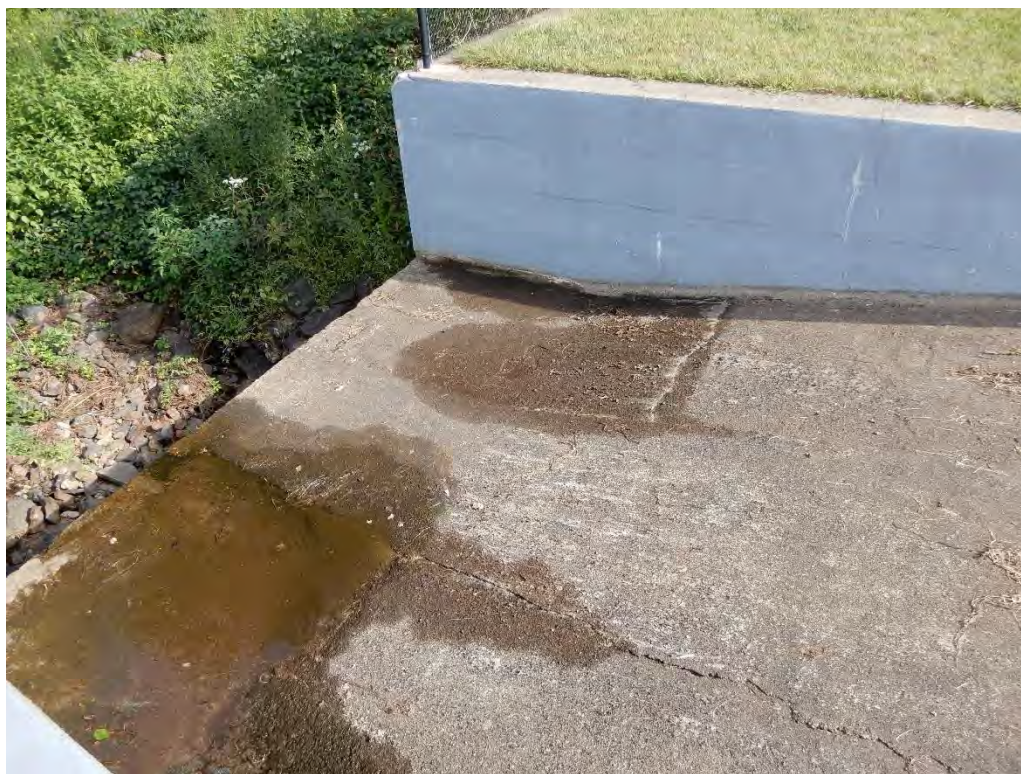
Photo 21b – A closeup view of seepage collecting at the base of the spillway chute.

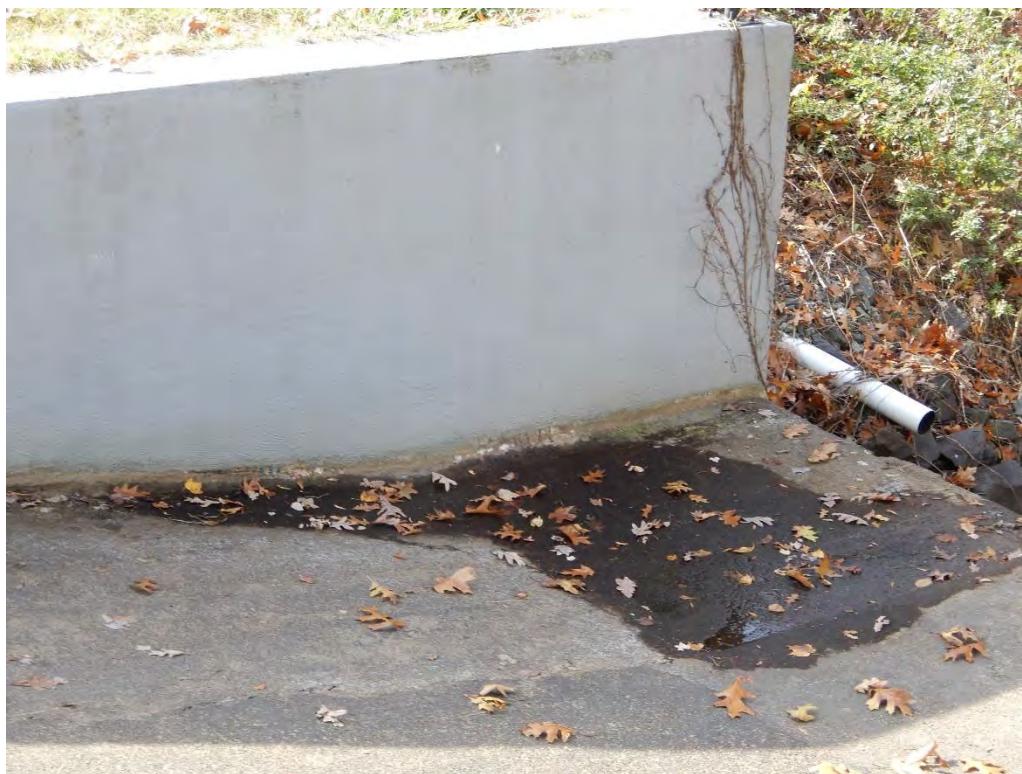
Photo 21c – Another view of the seepage at the base of the left side of the apron.

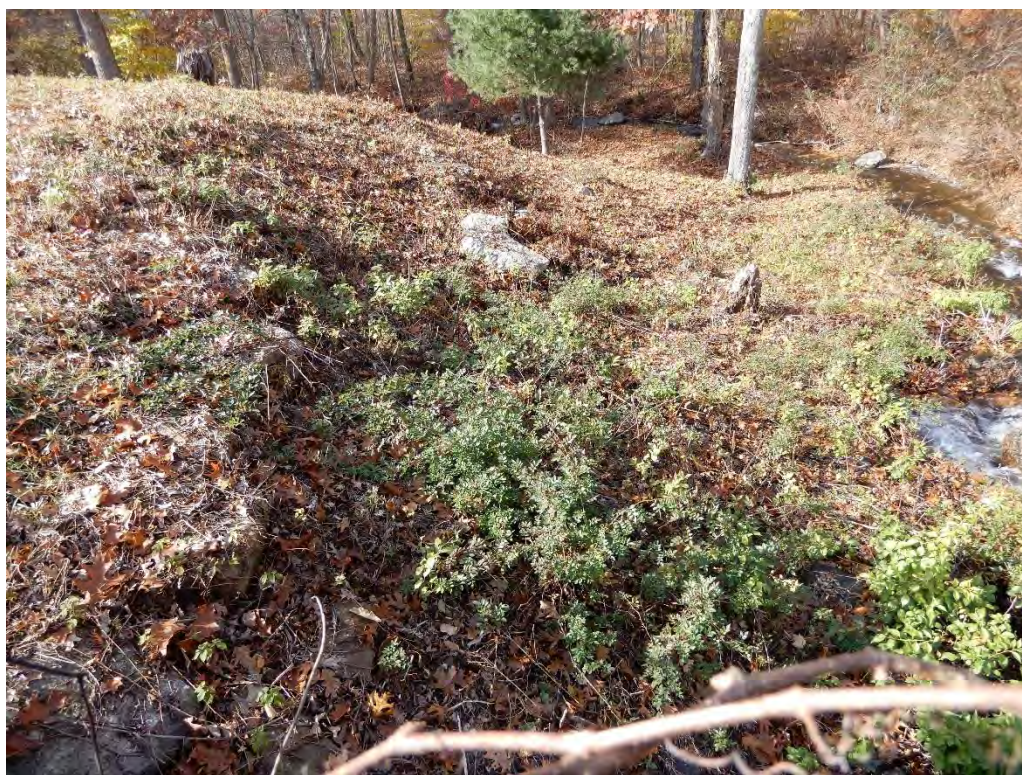
Photo 21d – Shrubby along the downstream embankment face left of the spillway. Although minor in scope, this area should be cleared, and a grass cover reestablished in line with other embankment areas for ease of maintenance.

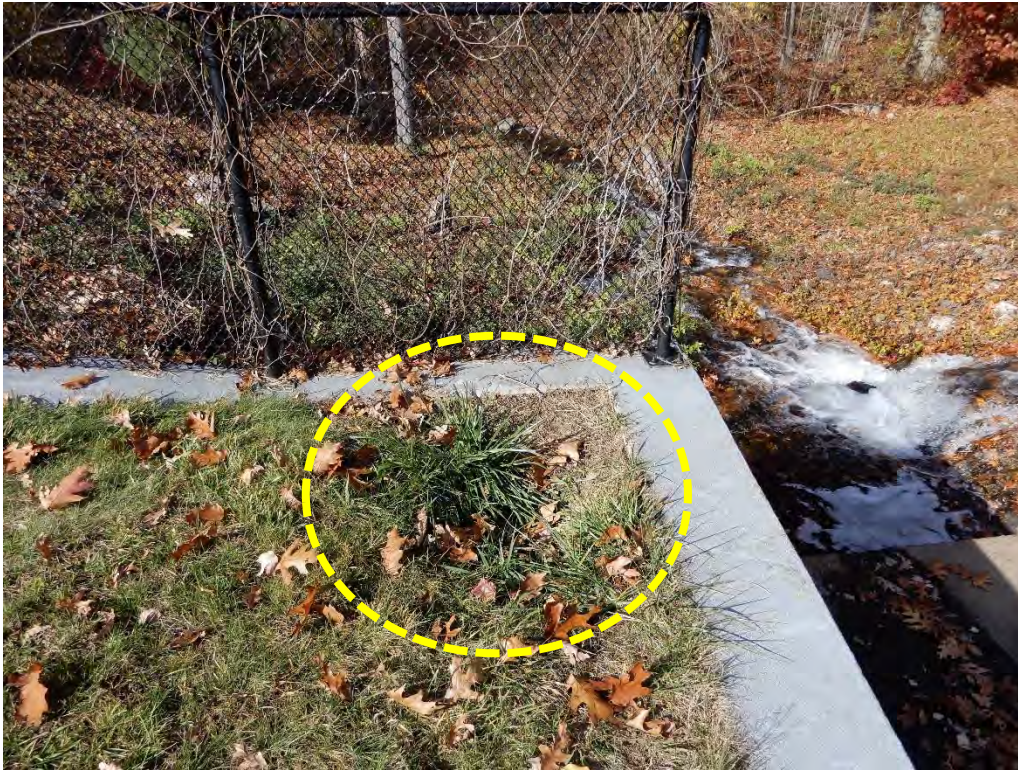
**Settlement / Alignment / Movement:** Nothing significant observed. There was, however, a small sinkhole on top of the left embankment directly adjacent to the left downstream corner of the training wall. This depression was approximately 1.2 ft. in diameter and 0.8 ft. deep.

Photo 21e – A minor depression adjacent to the left side training and wing walls. This area should be filled in and monitored, particularly as it is situated above a section of the training wall wherefrom minor seepage emanation was observed.

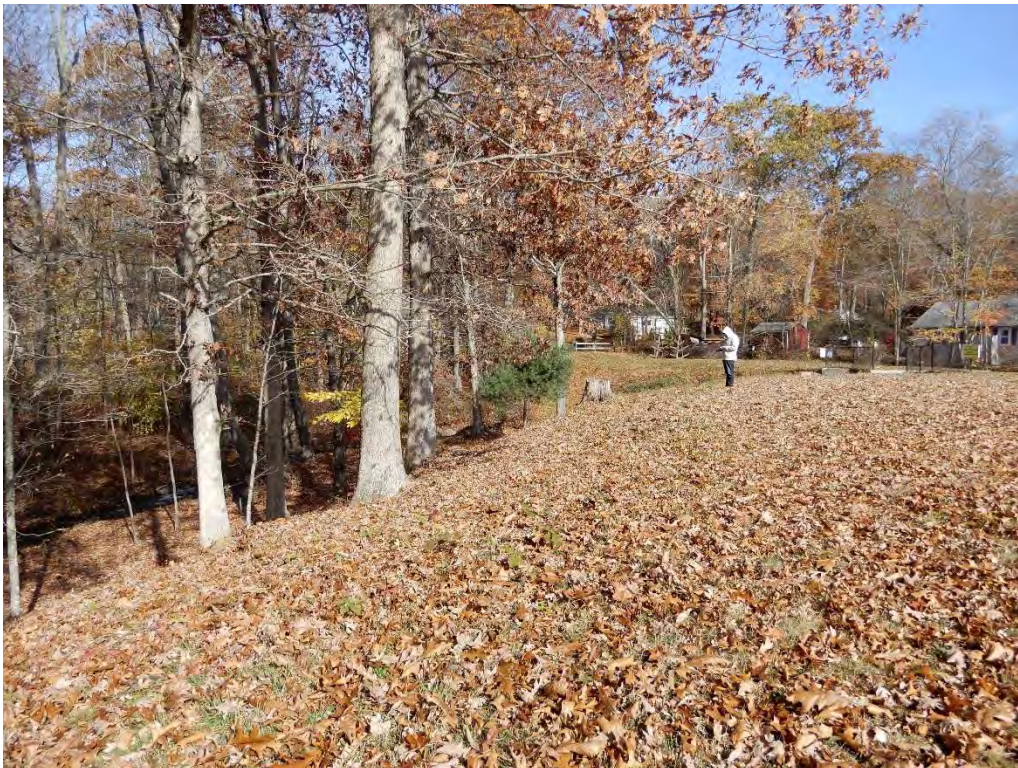
Photo 21f – Trees present along the left downstream embankment face. This growth should be cleared from the embankments and areas with 25' thereof, and a grass cover established and maintained.

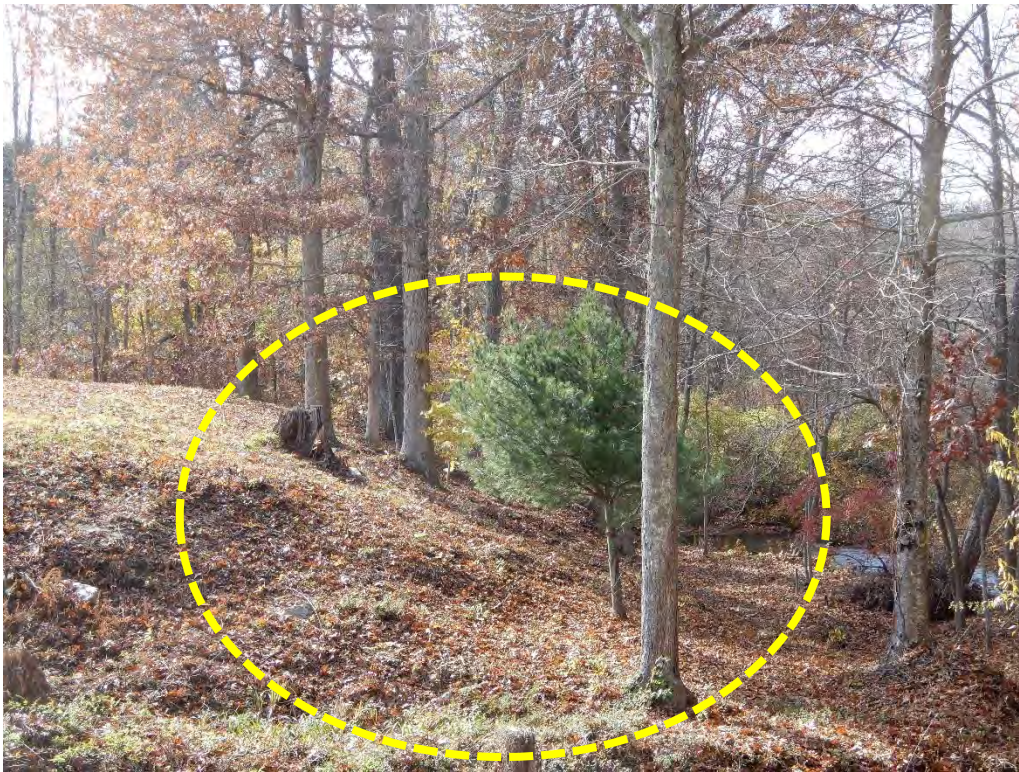
Photo 21g – Another view of the trees present along the left downstream embankment, seen from the opposite perspective.

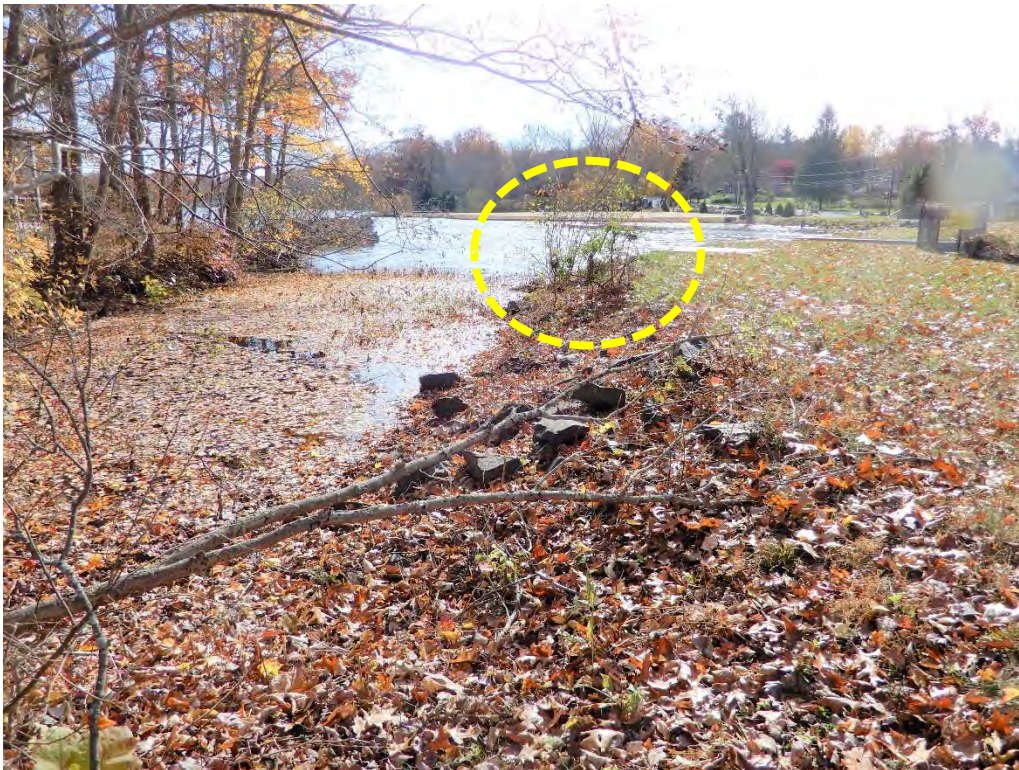
Photo 21h – Minor brush and debris to be removed from the right upstream side.

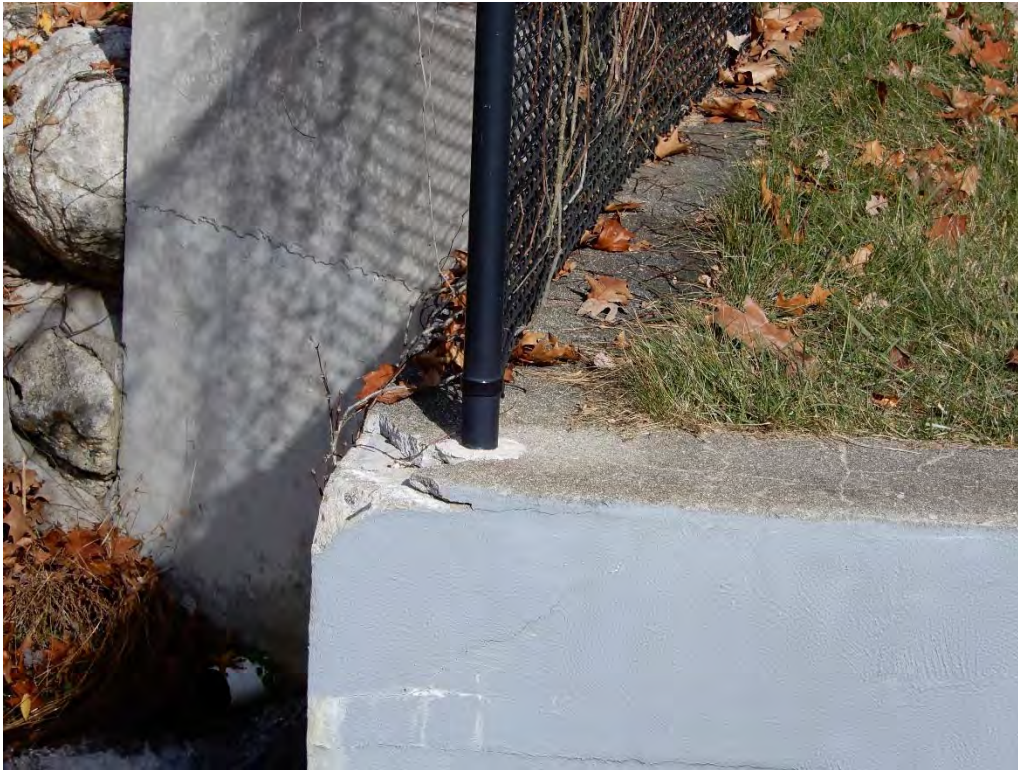
Photo 21i – Cracking and deterioration at the downstream corner of the right side training wall. This issue appears to have been caused by the adjacent fence post set into the concrete with expansive grout, which has prompted the cracking and chipping.

3. **Concrete Issues** – As pointed out within the report and shown in several photos, minor concrete cracking issues were noted. These should be repaired as soon as practicable. There are many good concrete patching and epoxy products available for this purpose; if assistance is required, an engineer should be consulted.

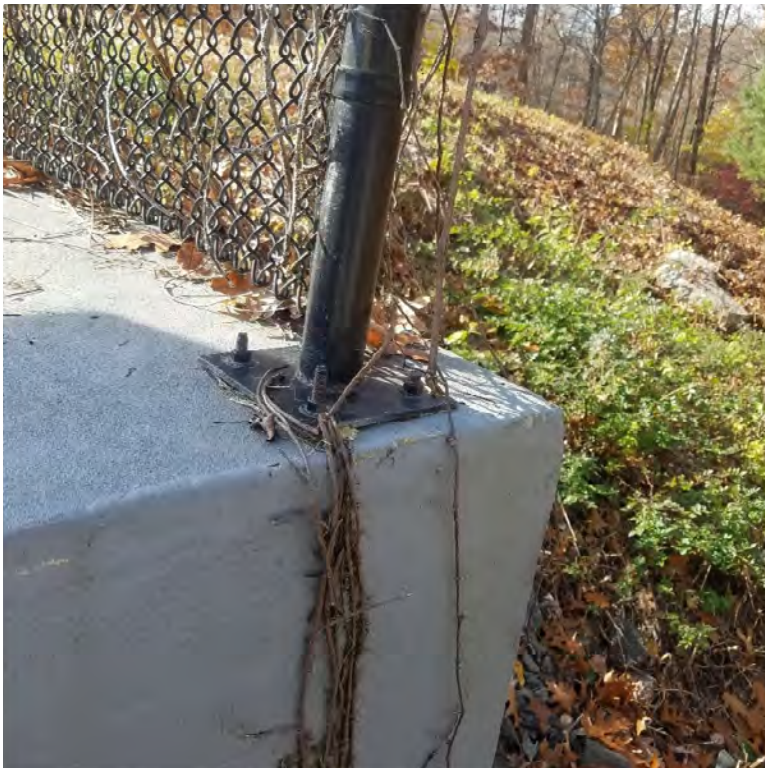
Photo 21j – For comparison purposes, the end post atop the left side wing wall has a bracket attachment rather than being set into the wall. No concrete issues are present.

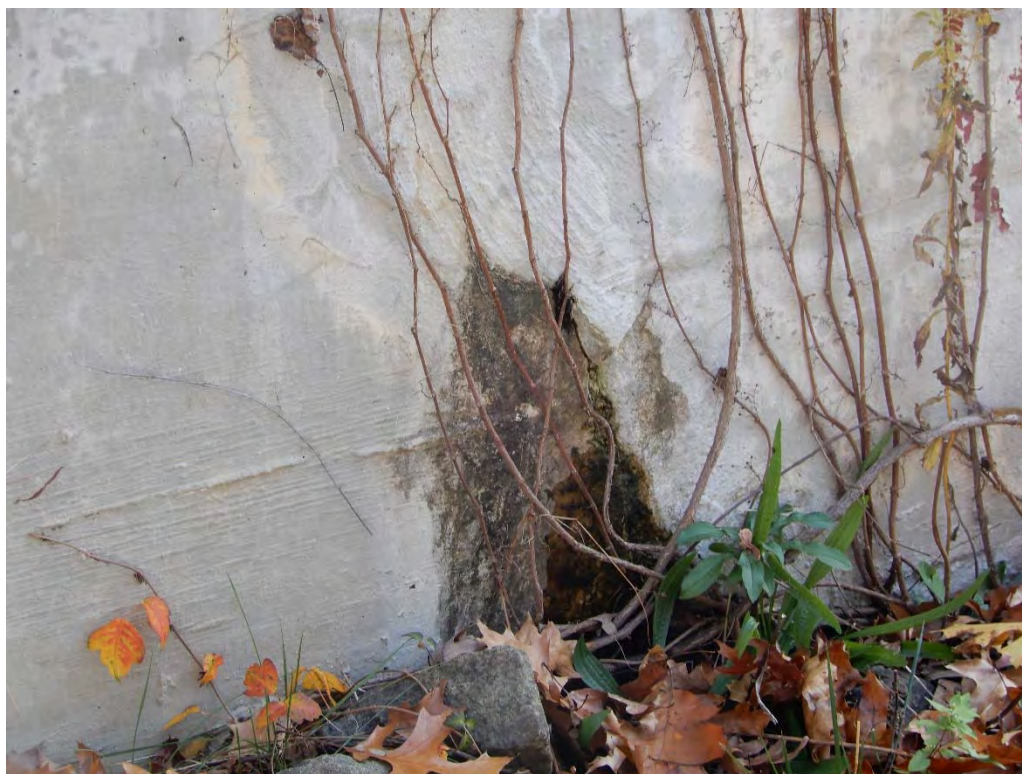
Photo 21k – A section of minor concrete deterioration along the downstream face of the right side wing wall. This area should be cleared and patched.

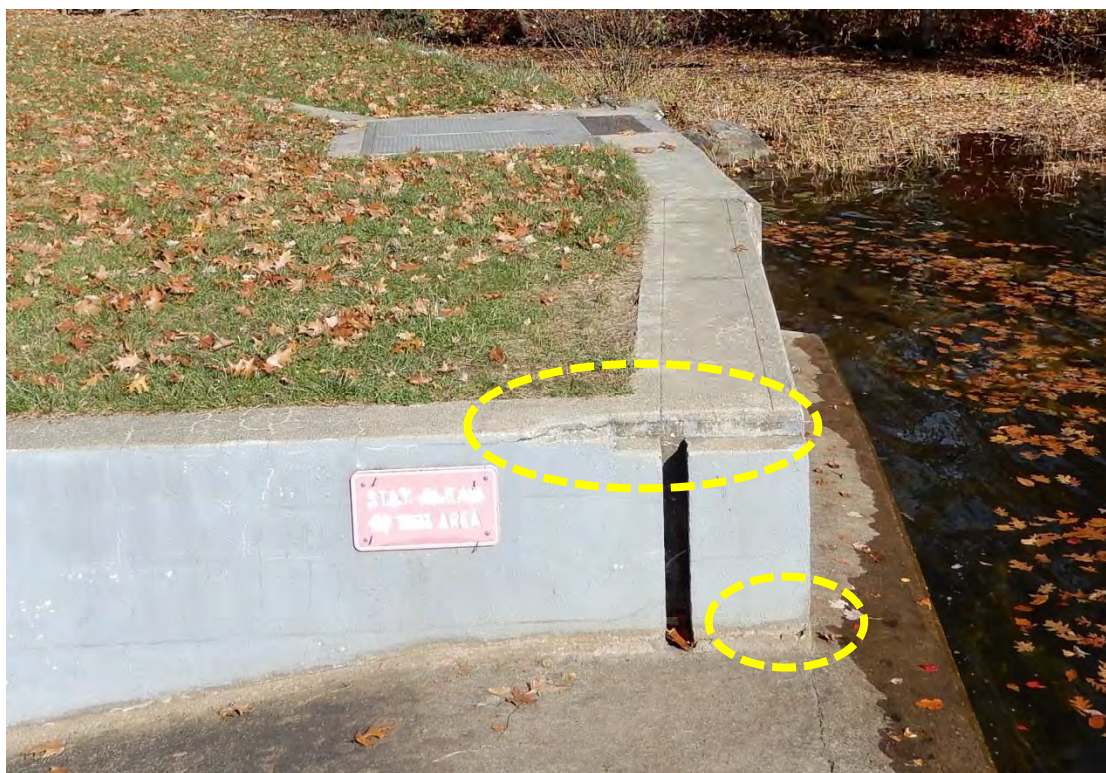
Photo 21l – Two concrete areas with minor issues, one a longitudinal crack at the top and a small open crack at the right bottom base.

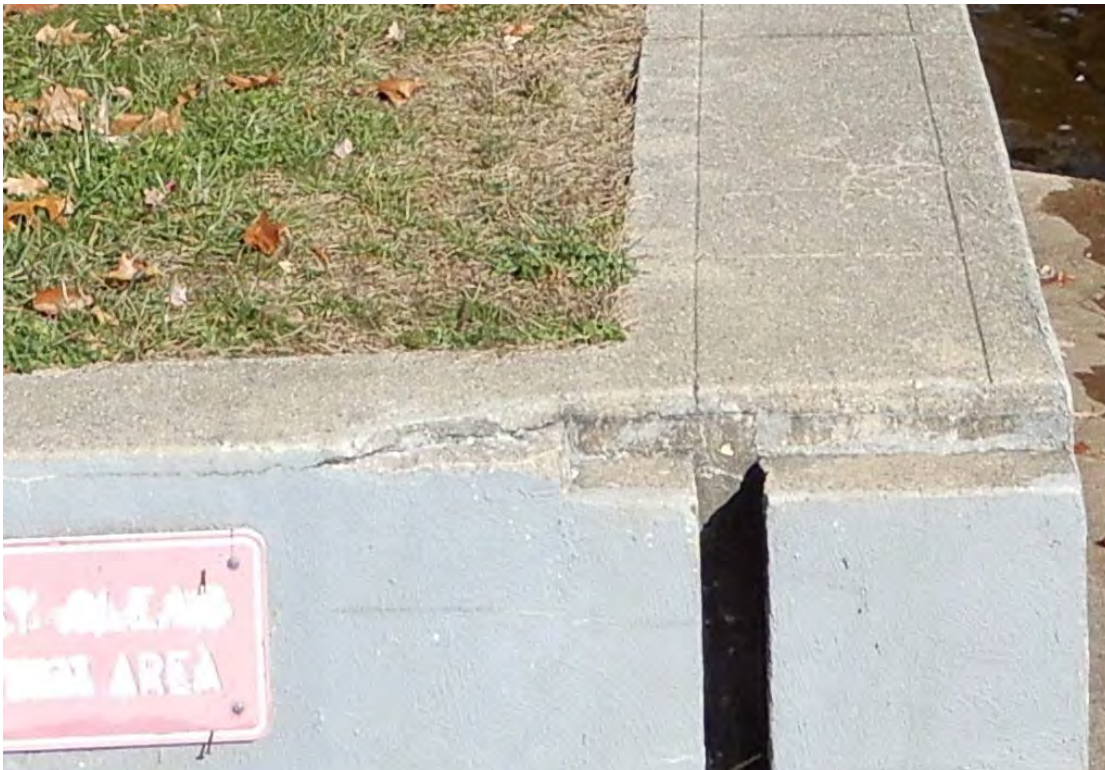
Photo 21m – A closeup of the top crack in the prior photo.

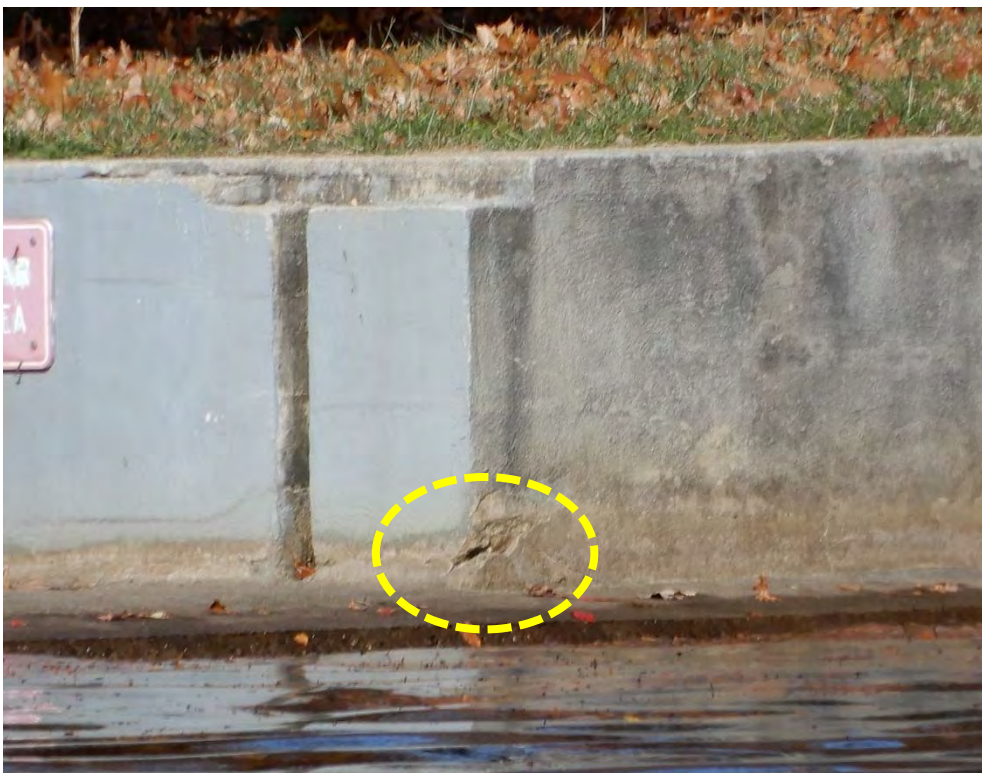
Photo 21n – A closeup of the lower right side crack issue at the base of the training wall.

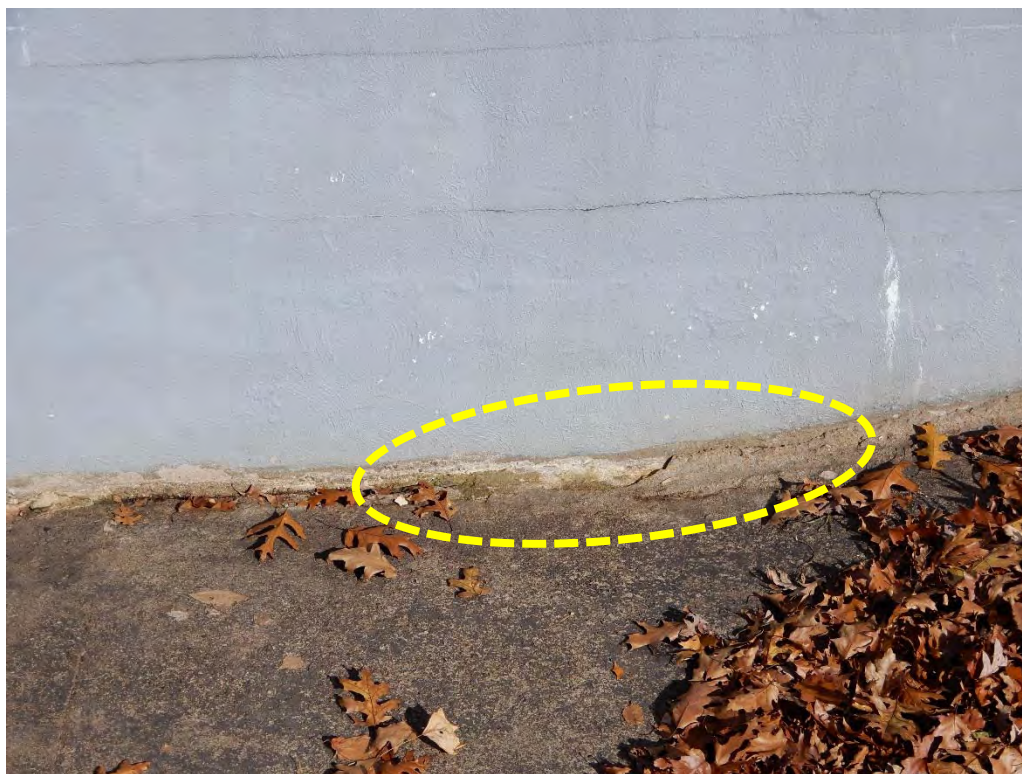
Photo 21o – A small area of cracked grout at the joint along the base of the right side training wall near the bottom of the apron.
